**LAND AT SANDFIELD, WEST LAVINGTON,  
WILTSHIRE**

**TREE SURVEY AND ARBORICULTURAL IMPACT ASSESSMENT  
FOR  
PROPOSED RESIDENTIAL DEVELOPMENT**

On behalf of  
**GAIGER BROS LTD.**

**April 2017**

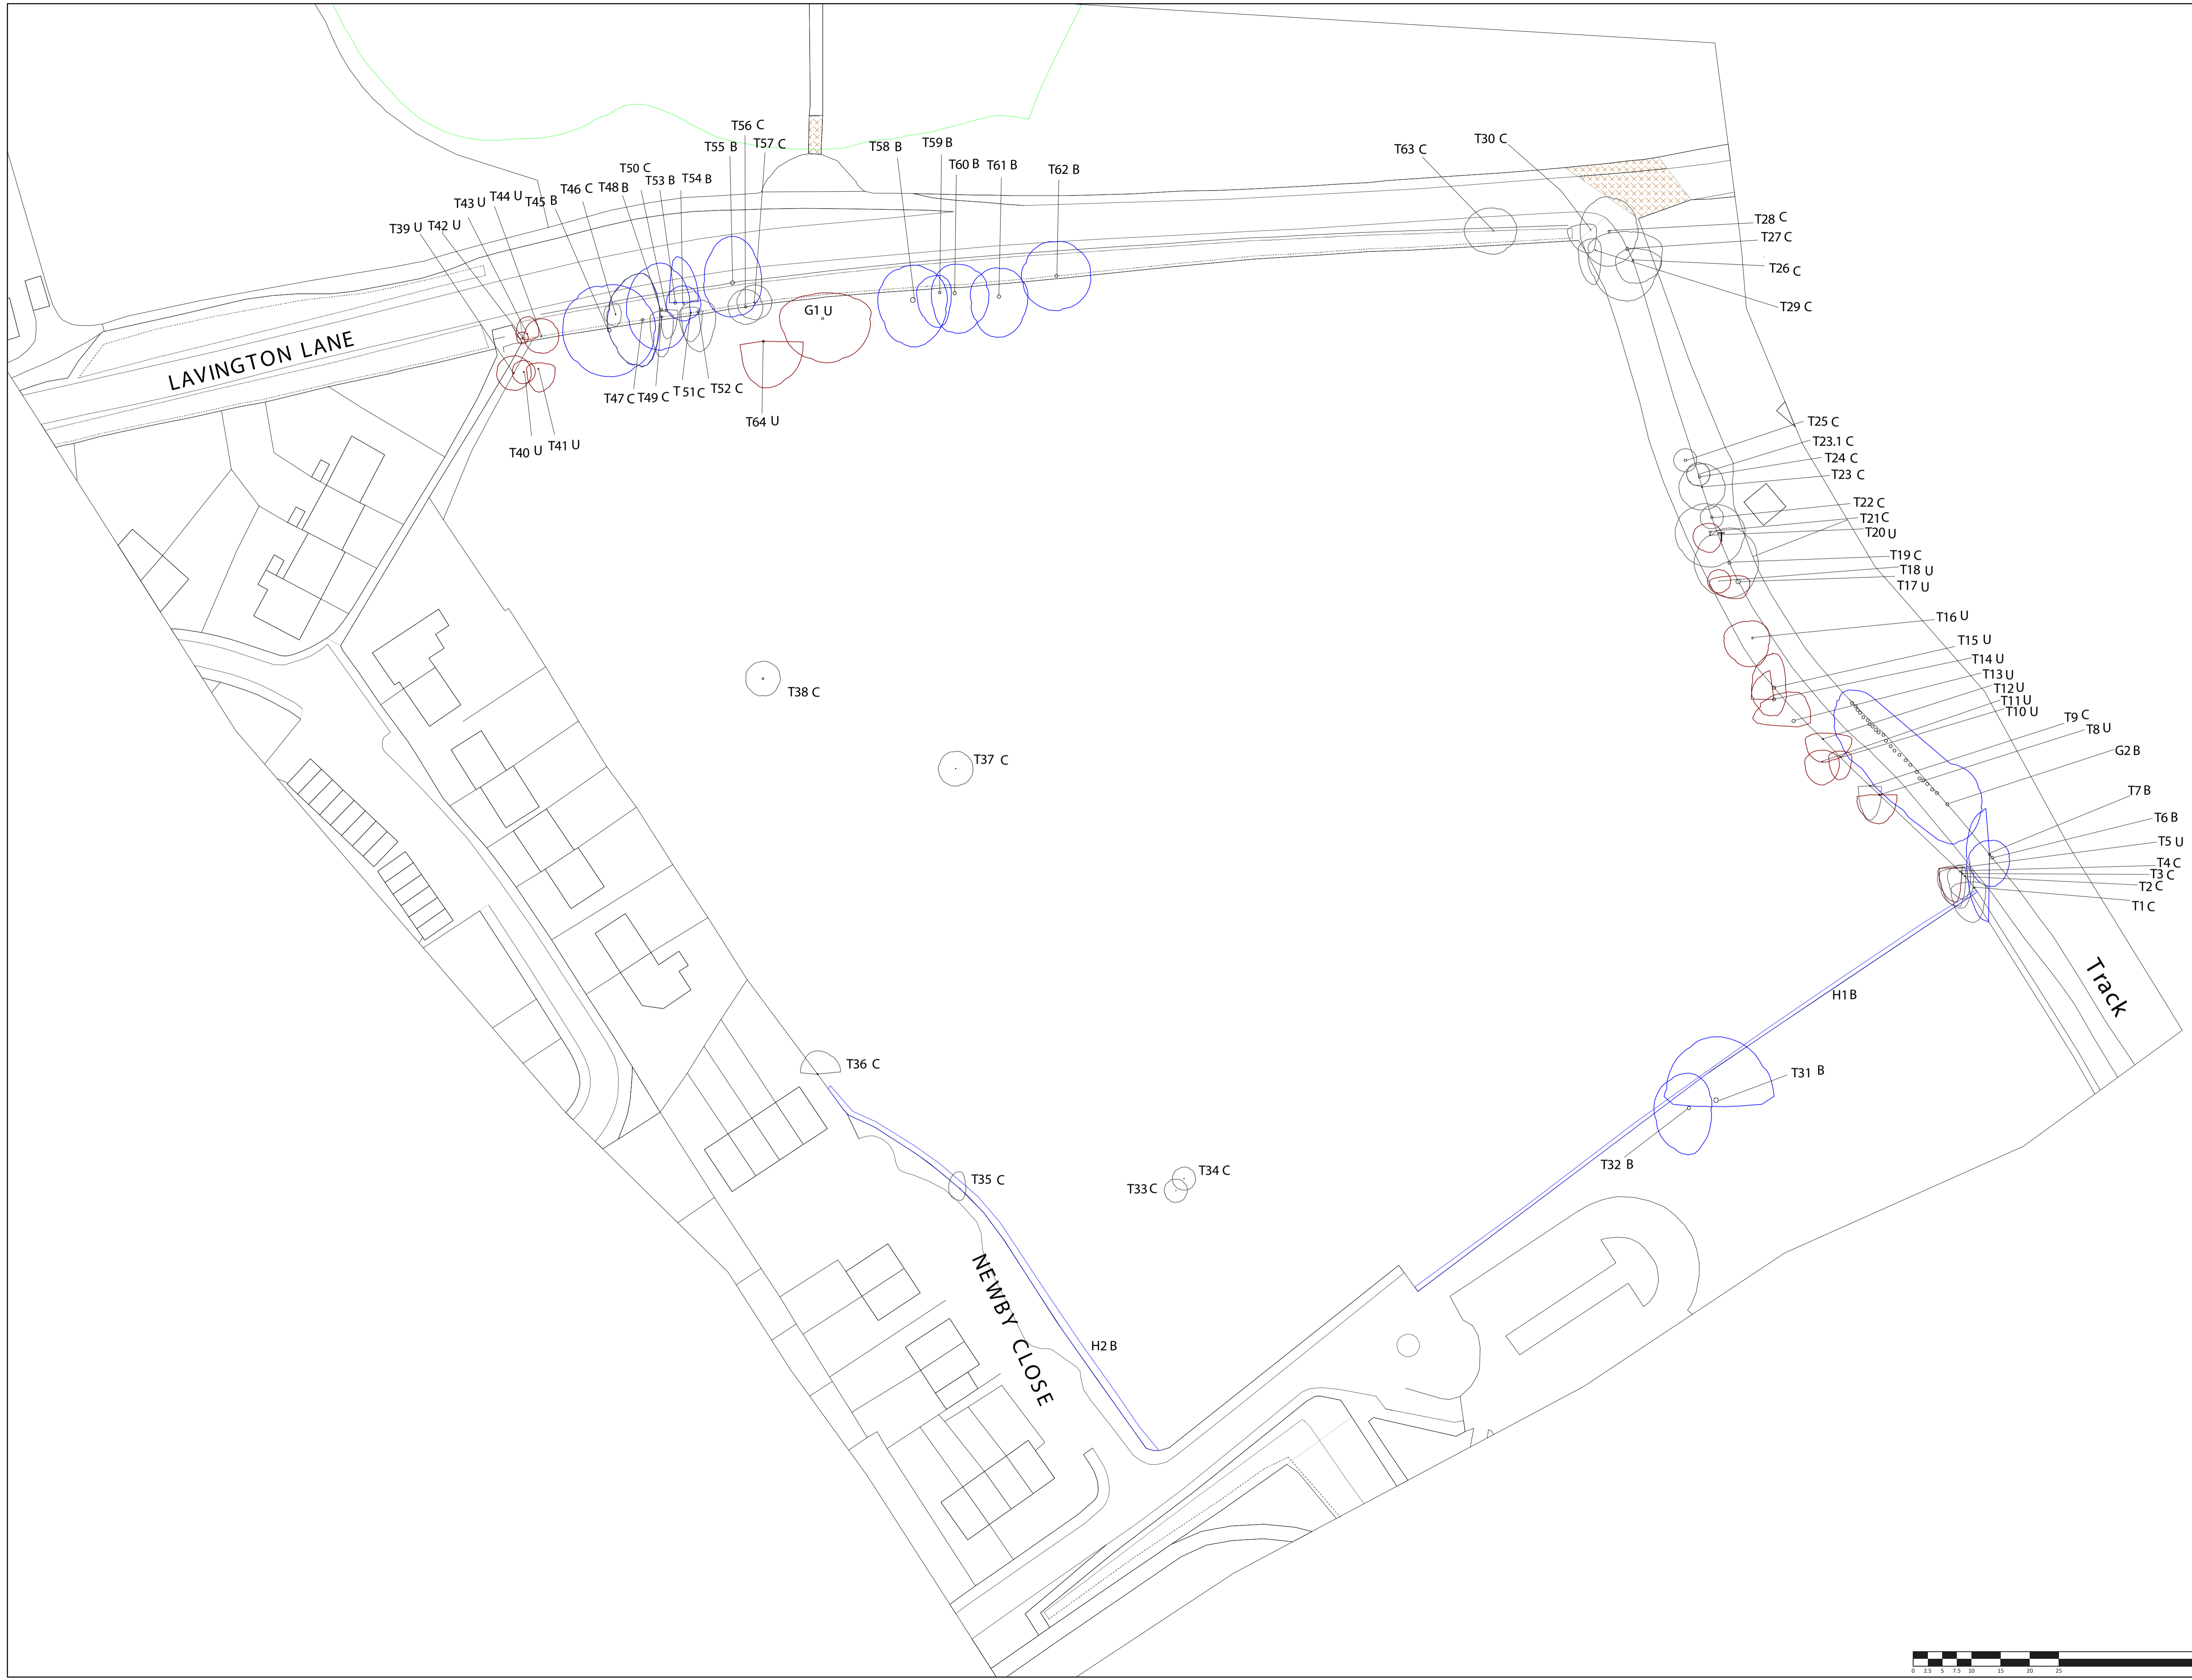
Client:		Ganger Bros Ltd	
Project:		Land at Sandfield, West Lavington	
Drawn By:		Tree Survey Plan	
Figure number:	Scale:		
Fig. 2	1:500 @ A1		
Dr:	Ch:	Date:	Rev:
TA	WH	Apr 27

**5.7** Trees T1 to T5 are four misshapen Leyland cypress (*X Cupressocyparis leylandii*) and one grey poplar (*Populus x canescens*) located within the south-eastern corner of the site. The trees are largely suppressed by the larger offsite trees and lean to the southwest in search for light. The poplar also has significant squirrel damage on the upper main stem, which is an entry point for future decay. The trees are of limited quality and the conifers have been awarded a C1 category with the poplar awarded a U-grade category. The removal of these trees would allow more suitable planting to be undertaken.

**5.8** Tree T8 is a semi-mature sycamore (*Acer pseudo-platanus*), located on the edge of the site, which is shrouded in ivy and in a poor condition. The tree has been awarded a U-grade category. The removal of this tree is recommended.

**5.9** Tree T9 is a semi-mature common ash (*Fraxinus excelsior*) located close to T8. The tree is suppressed with a heavy lean to the south. The tree is of limited quality and has been awarded a U-grade category. The removal of this tree is recommended.

**5.10.** Trees T10 to T12, T18 and T39 to T44 are semi-mature English elm (*Ulmus procera*) located on the northern and eastern boundaries. The trees are of limited overall quality and likely to succumb to Dutch Elm Disease as they increase in size and stature. The trees have been awarded U-grade categories and are not expected to last longer than 10 years. Their removal is recommended.

**5.11** Trees T13 to 15 are three poorly-shaped, ivy-clad veteran whitebeam (*Sorbus aria*) located on the top of the bank adjacent to the sunken bridleway. Although the trees are of a significant size for the species, they have been awarded a U-grade category due to their age and poor quality. Their removal is recommended.

**5.12** Tree T16 and T17 comprise a mature and a veteran sycamore (*Acer pseudoplatanus*), located on the edge of the steep bank bordering the sunken bridleway. Both trees have been topped in the past with T17 covered in thick ivy and sounding hollow in the lower stem. The trees have been awarded a U-grade category due to their location and condition. It is recommended that the trees be felled or coppiced.

**5.13** Trees T19, T20, T21 comprise two maturing sycamore (*Acer pseudoplatanus*) and one mature elder (*Sambucus nigra*) located on the steep bank bordering the bridleway, all of which appear to have been lopped in the past. The sycamore T19 has a badger sett 5.0m to the south-west and has notable squirrel damage on the upper stems. Both sycamores have been allocated C1,2 categories whilst the elder has been awarded a U-grade category. It is recommended that the trees be felled or coppiced.
