**LAND AT SANDFIELD, WEST LAVINGTON,  
WILTSHIRE**

**TREE SURVEY AND ARBORICULTURAL IMPACT ASSESSMENT  
FOR  
PROPOSED RESIDENTIAL DEVELOPMENT**

On behalf of  
**GAIGER BROS LTD.**

**April 2017**

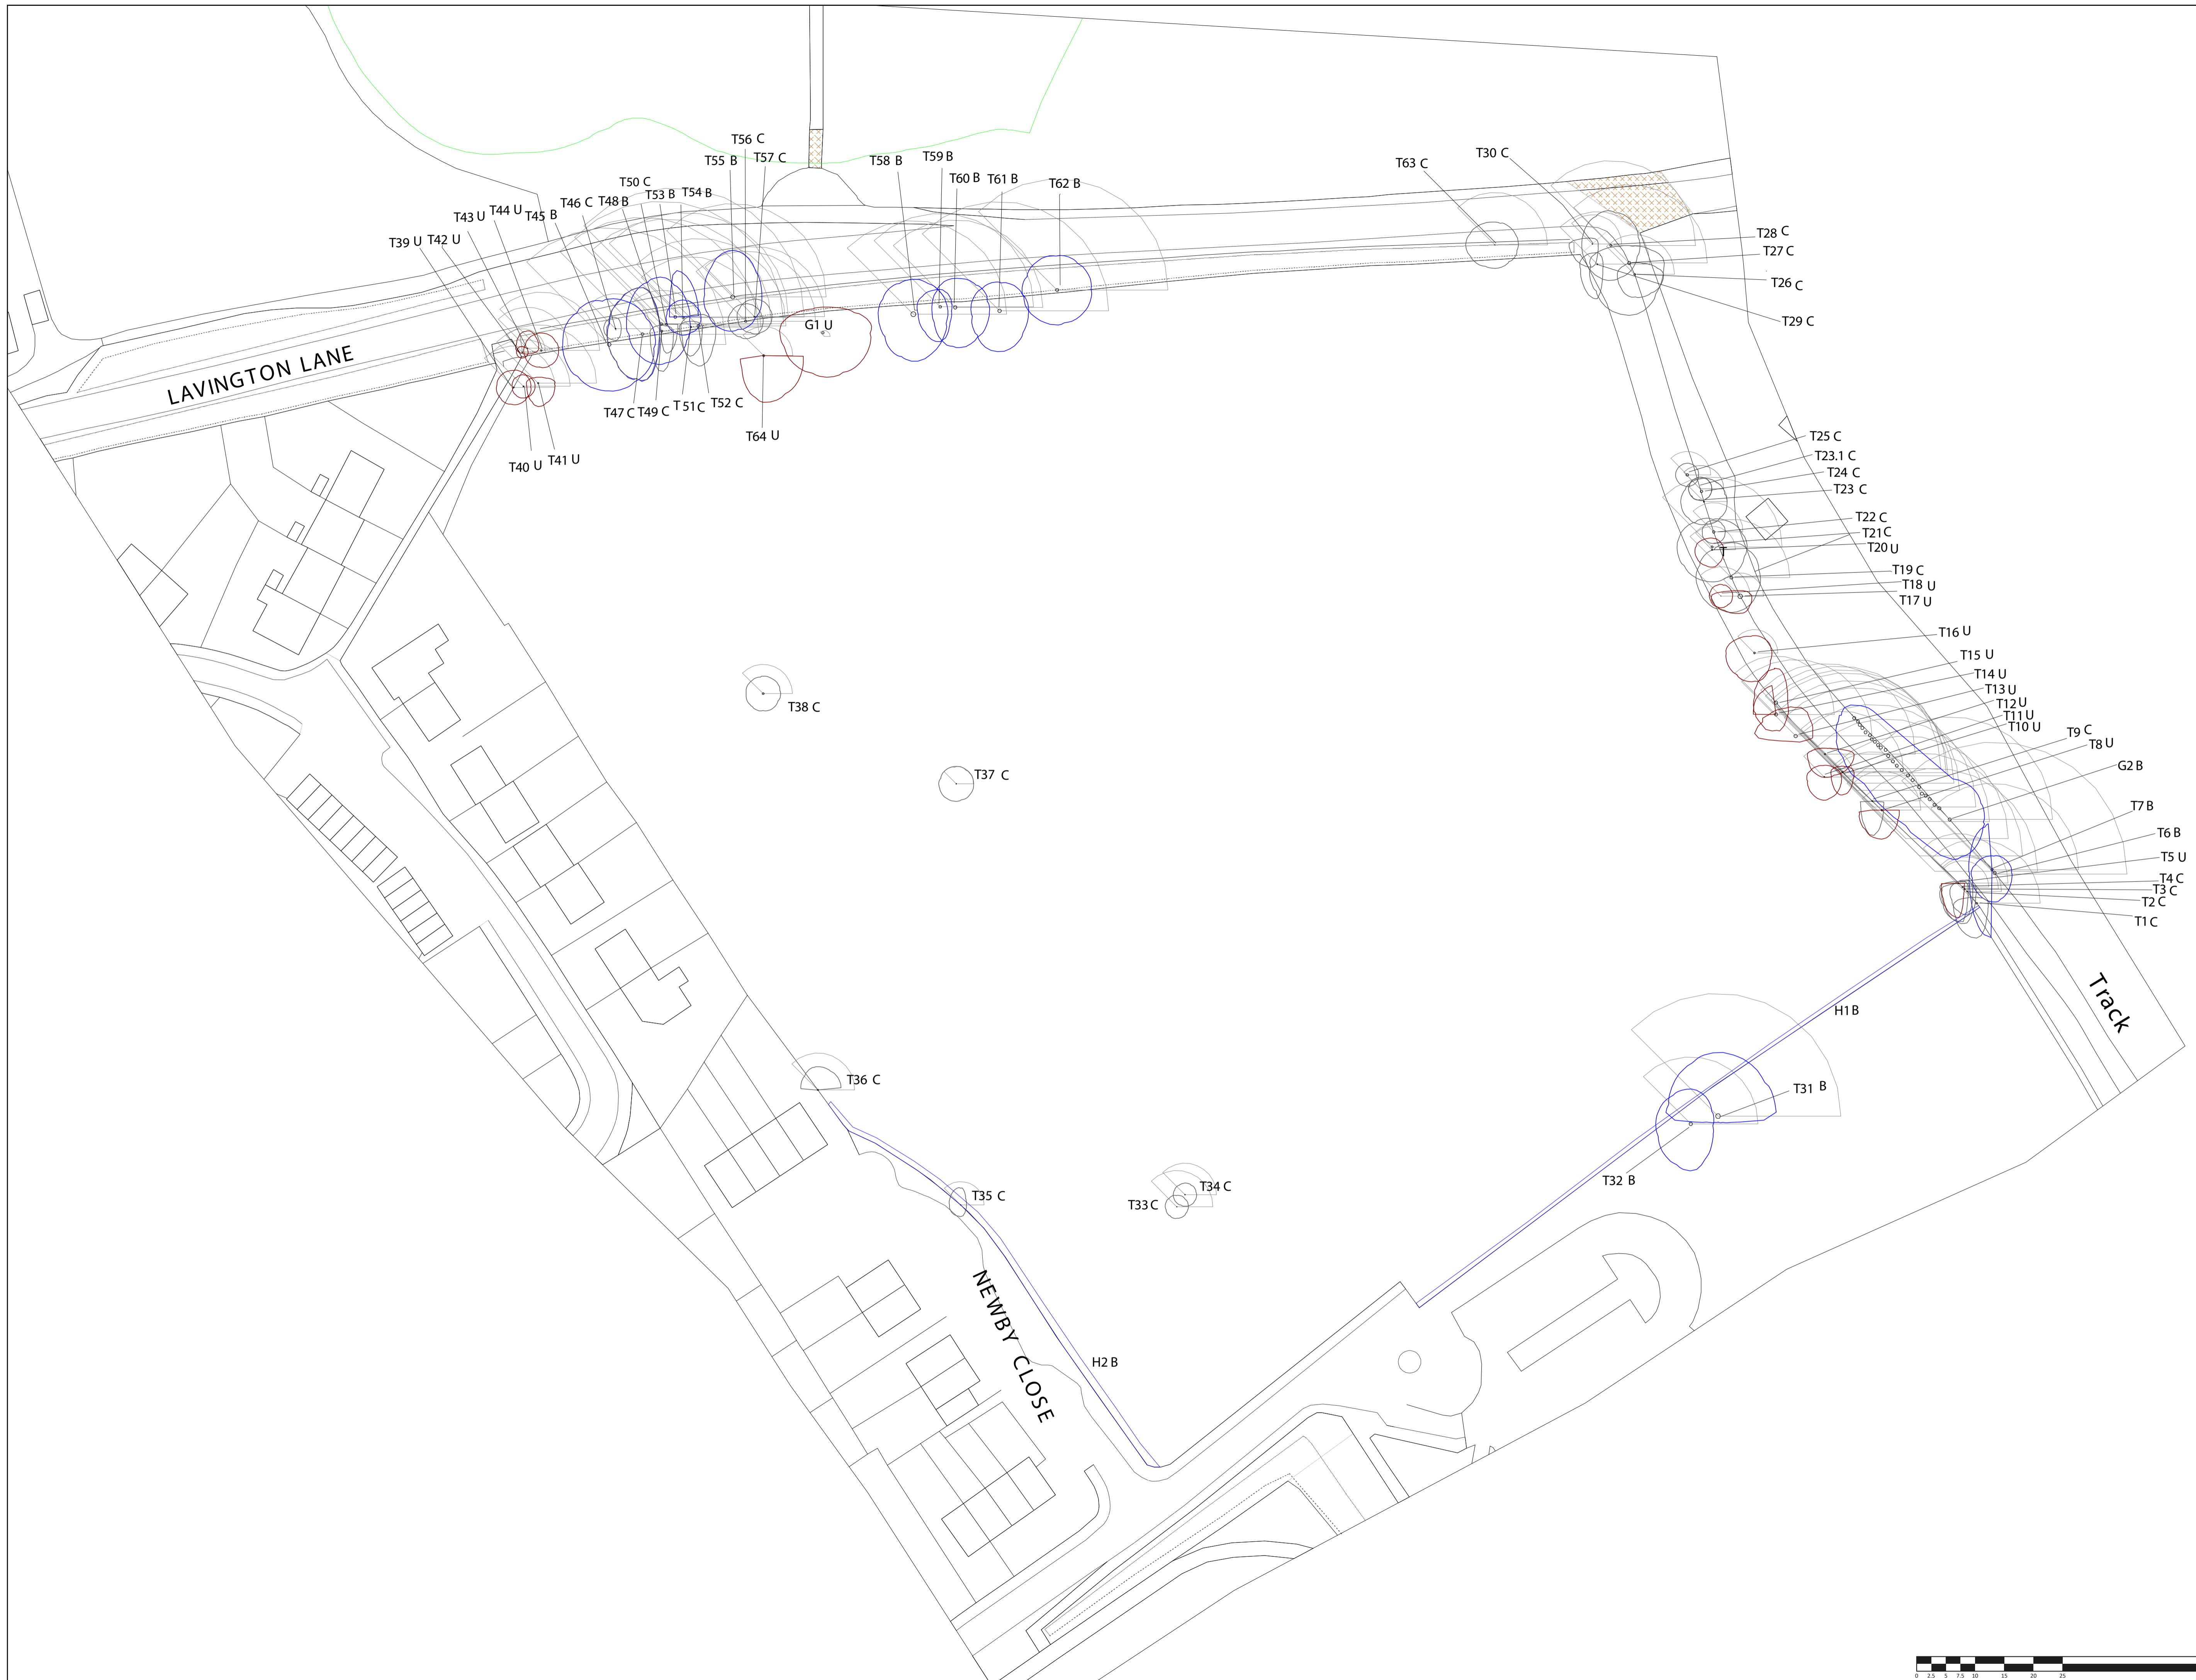
Client:		Ganger Bros Ltd	
Project:		Land at Sandfield, West Lavington	
Drawn By:		Tree Survey Plan	
Figure number:	Scale:		
Fig. 2	1:500 @ A1		
Dr:	Ch:	Date:	Rev:
TA	WH	Apr 27

**8.1** The Tree Survey Plan (Fig.2) demonstrates that a large section of the site could be constructed incorporating site compounds, soil heaps, services routes etc. outside the RPAs of the retained trees and hedging, with the removal of trees T28, T30, T63, T61 and T62 required to create the access and visibility splays to the highway standard. Further minimal ground work within the RPAs of T58 to T60 will also be required as part of the new access works, which will need to be undertaken by hand in line with an approved method statement.

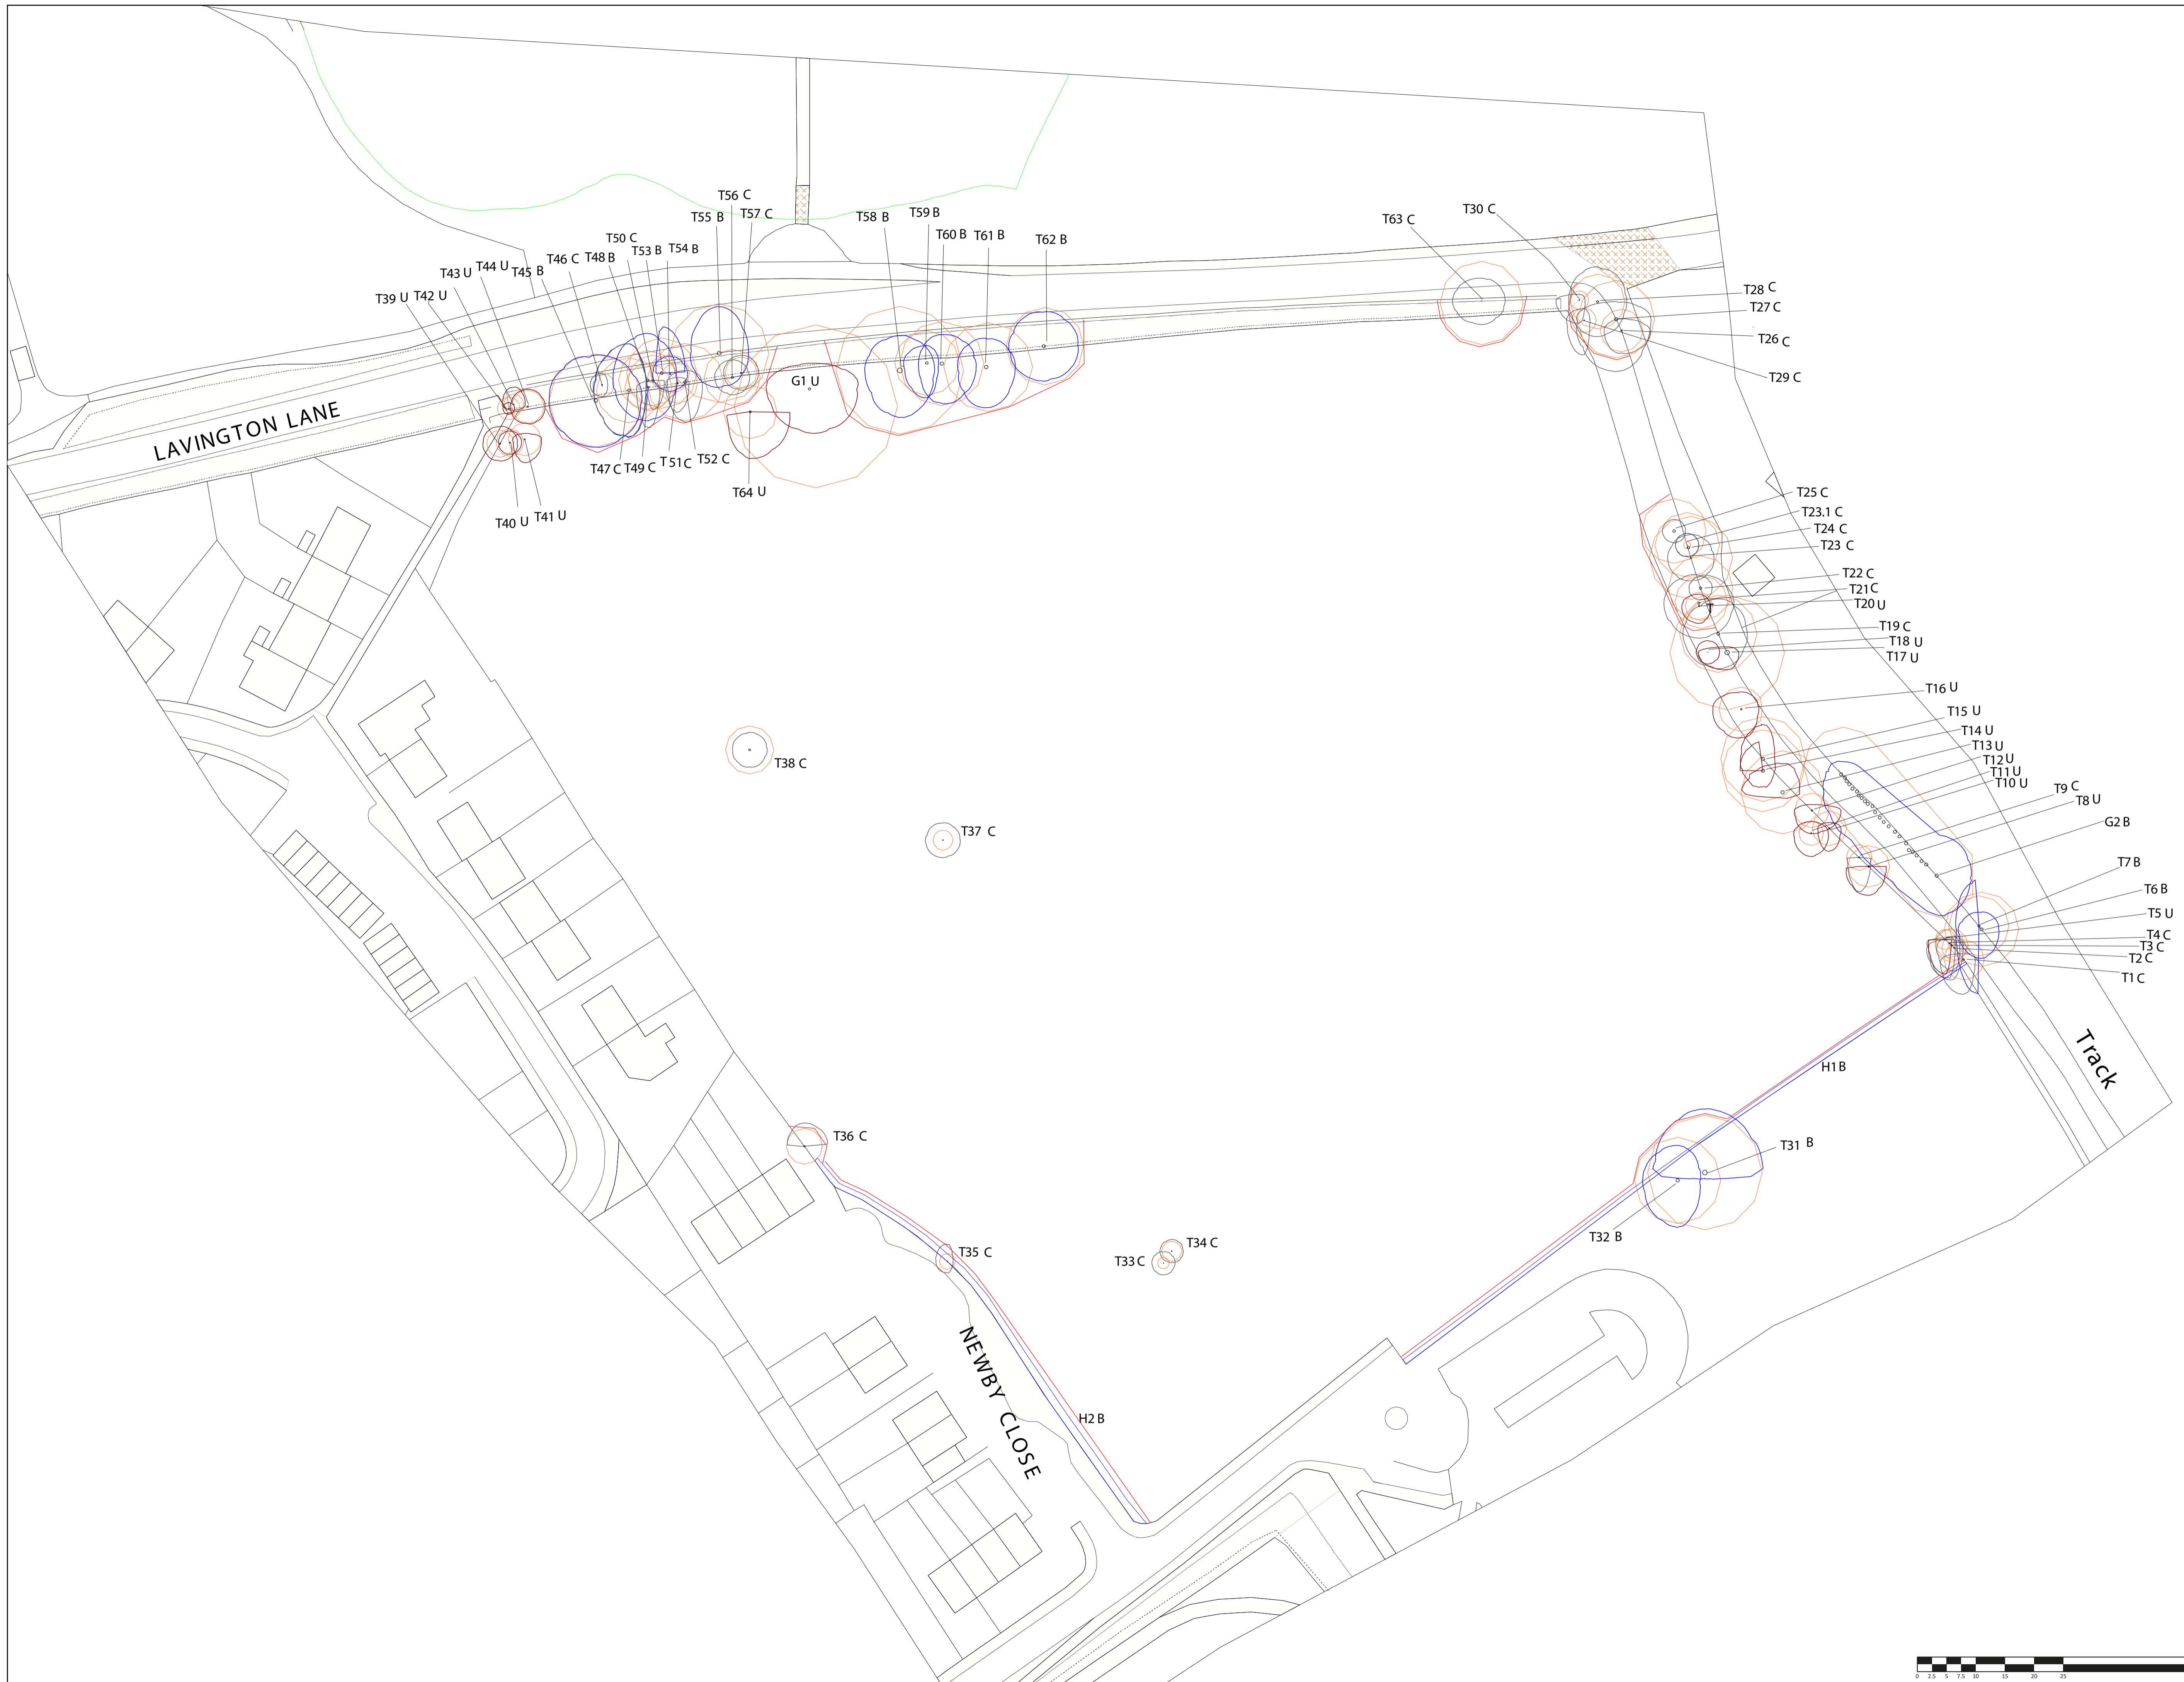
Client:		Ganger Bros Ltd	
Project:		Land at Sandfield, West Lavington	
Drawn By:		Tree Shadow Plan	
Figure number:	Scale:		
Fig. 3	1:500 @ A1		
Dr:	Cr:	App:	Rev:
TA	WH	Apr 27

**8.4** The Tree Shadow Plan (Fig3.) also demonstrates that shading patterns for the retained trees will not result in excessive shading over the proposed site.
